SHORT COMMUNICATION

JUMPING OF BELL HOUSES CAUSED BY NEAR-FIELD GROUND MOTION. CASE HISTORIES AND SHAKING TABLE EXPERIMENT

SUMMARY

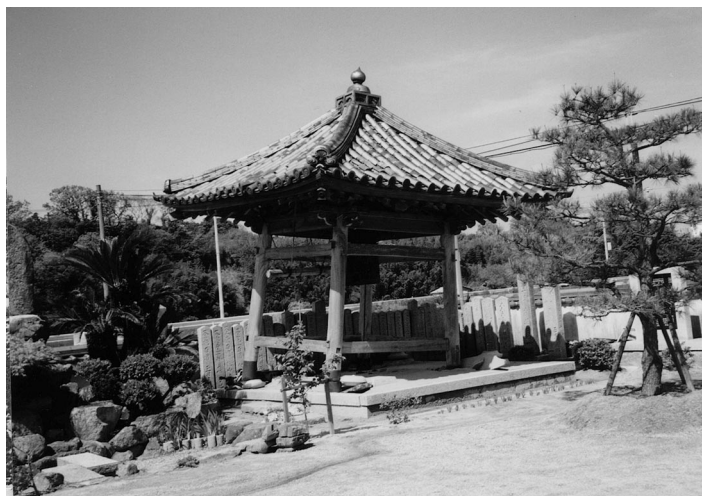
Figure 3. Photo of the Bell House at Saimyo-ji after the 1995 Hyogo-ken Nanbu earthquake

Figure 3 shows the Bell House at Saimyo-ji after the earthquake. The displaced House was inclined a little because one of the shoe-stones jumped with a column, and also because the floor slab of concrete was partly broken due to the landing impact of the House.

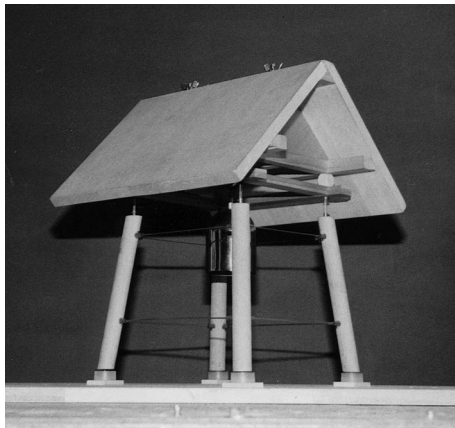
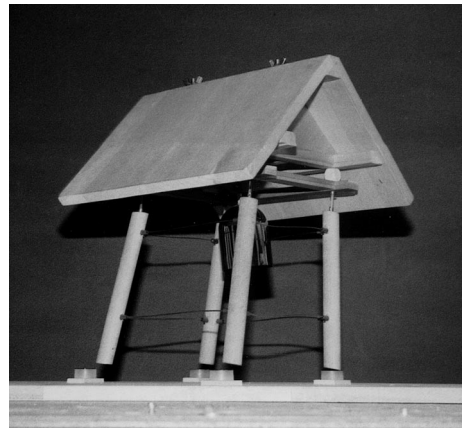
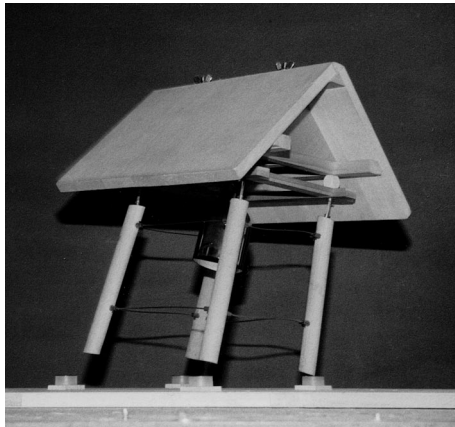
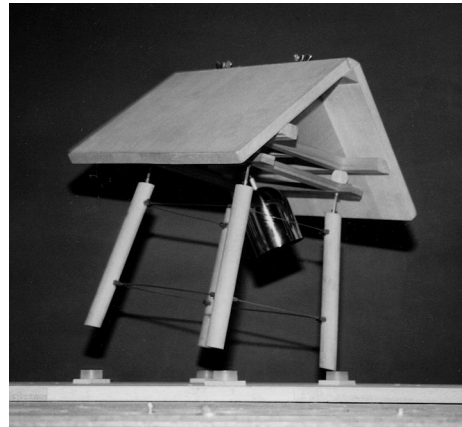
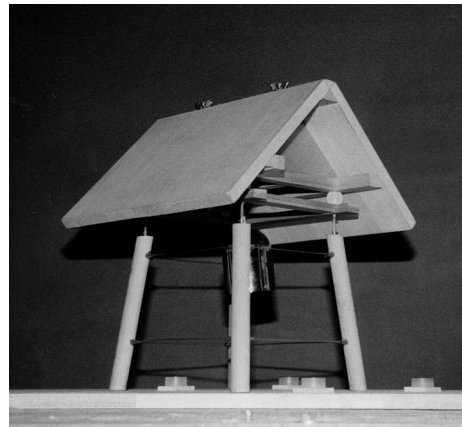
Photos in Figure 7 show several snap shots of the jumping. When the still standing model shown in (a) is suddenly subject to a sinusoidal table shaking, its roof leans forward a little and then turns back, while the hanging-bell lags behind the roof as shown in (b). As the roof increases the backward displacement, it leans on one column with other three columns uplifted as shown in (c). During the stages (b) and (c), a considerable flexure is seen at the beams connected with the supporting column that keeps in touch with the base. Thus, the distance between the supporting column and the farthest one is remarkably shortened at their bottoms. The distortion may be called a pantograph-like distortion. As shown in (d) and (e), the whole of the model jumps off the table with all the beams stretched again. Finally, the column-bottoms land on the table, and the model leaves large displacement as shown in (f).

Figure 7. Snap shots of jumping of model Bell House
